## **AN EVALUATION OF PRODUCTS FOR WASHING AIRPLANES AND THEIR EFFECTS ON CORROSION**

Luz Marina Calle and Louis G. MacDowell  
NASA Kennedy Space Center  
Kennedy Space Center, FL 32899

### **ABSTRACT**

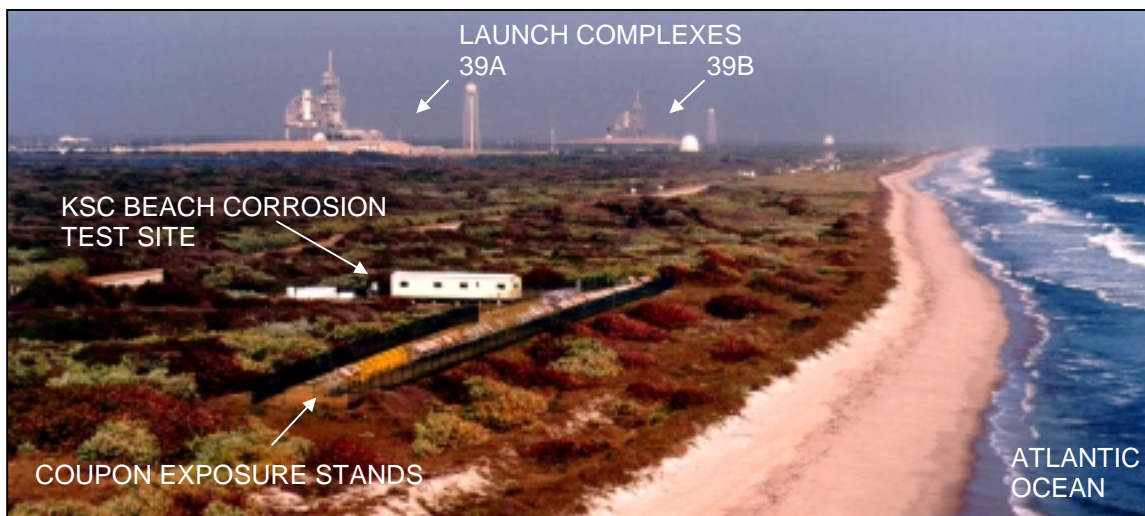
**FIGURE 3:** View of Beach Corrosion Site and Coupon Stands

Flat specimen panels, 4 by 6 inches (10 by 15 cm) by 1/16 to 3/16 inches (0.16 to 0.48 cm) thick, weighing 40 to 1200 grams, were exposed for two years to the marine atmosphere environment in racks manufactured in accordance with standard industrial procedures.<sup>4</sup> Figure 3 shows the close proximity of the specimen panels to the Atlantic Ocean at Kennedy Space Center.
